# **Lunar Dust Effects on Spacesuit Systems**

## **Insights from the Apollo Spacesuits**

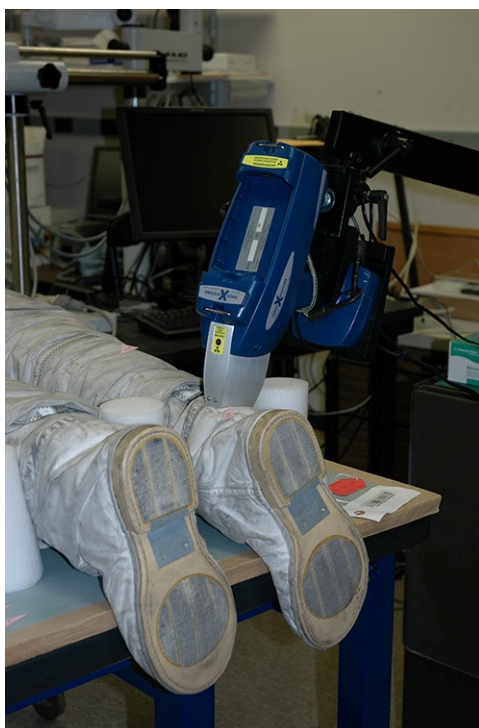
*Figure 3. Innov-X Systems portable ED-XRF spectrometer (blue unit), which is held in a positioning tripod for chemical analysis of the outer fabric of the Apollo 17 spacesuit.*

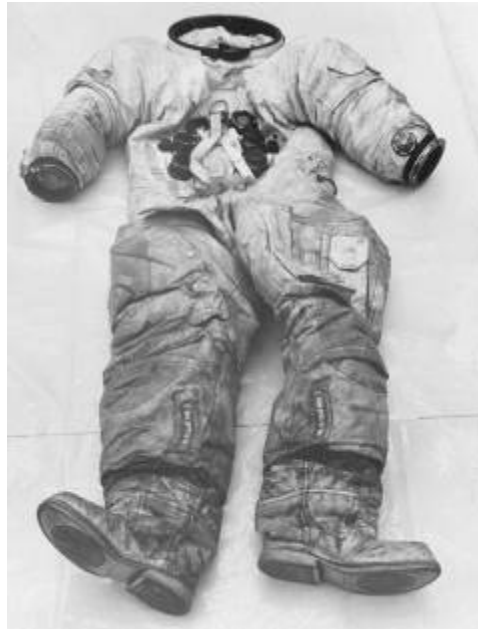
*Figure 5. ITMG from model A7L spacesuit worn on the lunar surface by Apollo 12 LMP Alan Bean. Image originally appeared in NASA TR-169-001, prepared at the WSTF.*

Of all of the spacesuits that were worn on the Moon, only that worn by Apollo 12 LMP Alan Bean was permanently disassembled for the purpose of post-flight analysis. This analysis was conducted at the Test Operations Office at the NASA White Sands Test Facility (WSTF) shortly after the flight, as documented in NASA Technical Reports TR-169-001 and TR-169-003 (Smith, 1970a, b). An image of the ITMG portion of the spacesuit, which was taken as part of the WSTF analysis, is shown in Figure 5.

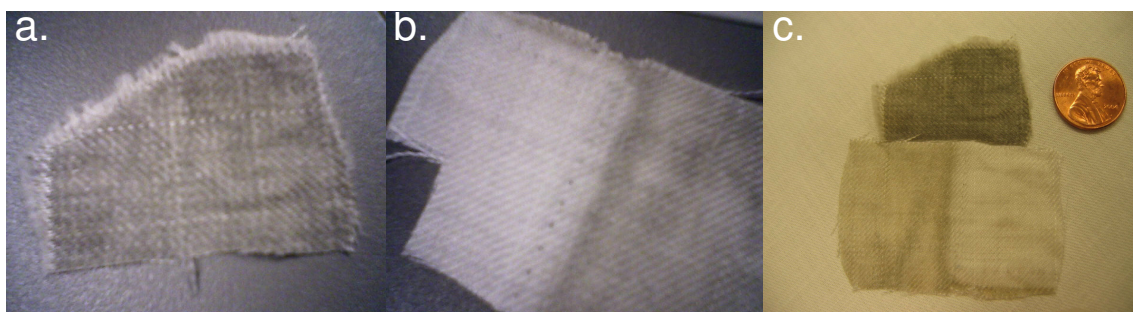
*Figure 6. Samples of outer fabric from Apollo 12 LMP spacesuit. (a) Outer surface of T-164 Teflon<sup>®</sup> outer abrasion fabric from left knee, (b) T-164 Teflon<sup>®</sup> fabric swatch from left shoulder; lighter area was covered under U.S. flag patch. (c) Comparative size of swatches shown in (a) and (b).*

(EPMA). To gain a greater understanding of the effect of lunar dust on the condition of fabric, the current study used SEM techniques to investigate three samples of ITMG outer fabric. The samples consisted of fabric swatches 4–6 cm<sup>2</sup> in size that were obtained from a highly worn and very dirty area directly on the ITMG left knee, and from an area on the left shoulder that was partially covered under a U.S. flag patch (Fig. 6). Although it is a single piece of fabric, the flag patch swatch was treated as two fabric samples; the covered portion representing unexposed material, and the uncovered portion represented exposed material. Thermal analysis confirmed that all fabric samples consisted of pieces of supplemental 1a-layer of T-164 Teflon<sup>®</sup> abrasion fabric that was added to the shoulder and knee areas of the A7L spacesuits (see Table 4).

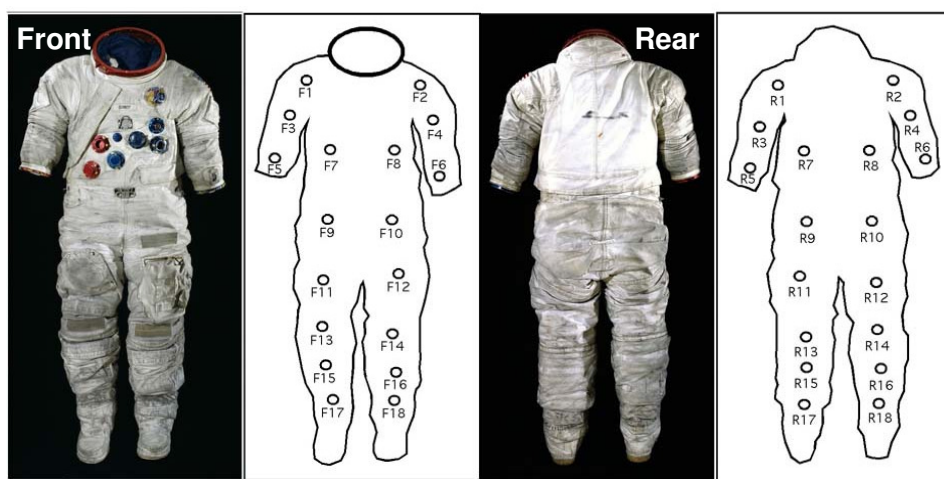
Figure 14. Particle sampling locations on the outer fabric of the Apollo 17 LMP ITMG.

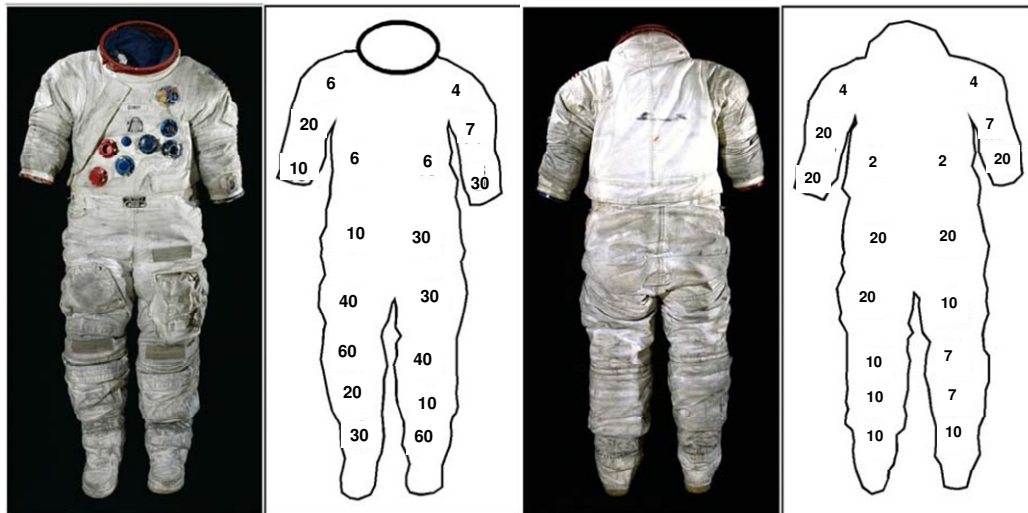
Figure 24. Concentration of Ti in units of  $\text{ppm} \times 10^2$  measured by ED-XRF for tape-sampled location on front (left) and back (right) of Apollo 17 LMP ITMG (see Fig. 14).

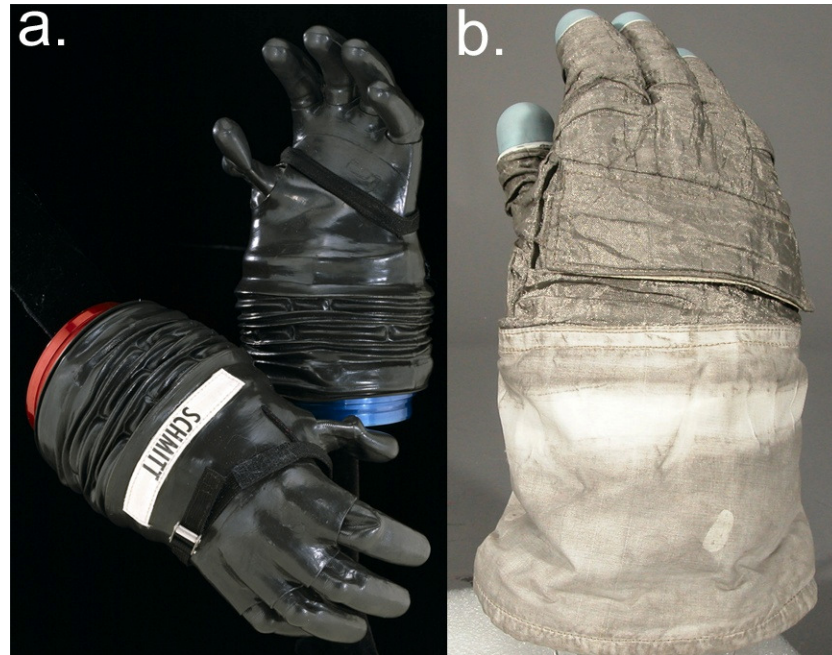
Figure 26. Examples of the two types of Apollo spacesuit pressure gloves.( a) Apollo 17 LMP IV pressure gloves, and (b) Apollo 17 LMP EV pressure glove. (Official Smithsonian images used by permission).

terial comprising its outer materials assembly (Fig. 26): (1) thumb tip and fingertip hard coverings that were made of Si-rubber-coated nylon tricot; (2) coverings on palm, thumb, and back of the hand that were made of woven Chromel-R metal fabric (coated with Si rubber on the palm and thumb to improve grip); and (3) a fabric gauntlet made of beta cloth that extended far enough up the arm to completely cover the inner face and the male-female quick-disconnect hardware that mated the glove to the rest of the suit. Optical microscope and SEM examination of selected areas of the outer materials on two EV gloves was performed to assess wear performance of these materials as possibly influenced by interaction with the lunar surface and lunar soil in particular
